Flying roadside stones—a deadly risk in a crash

Abstract: The crash of a coach with 58 occupants at 100 kmph revealed the danger of covering ditch areas with sharp stones 5–20 cm in size. Stones and dirt were sprayed into the coach compartment resulting in serious injuries and death. Road safety works need to address this factor in the future.

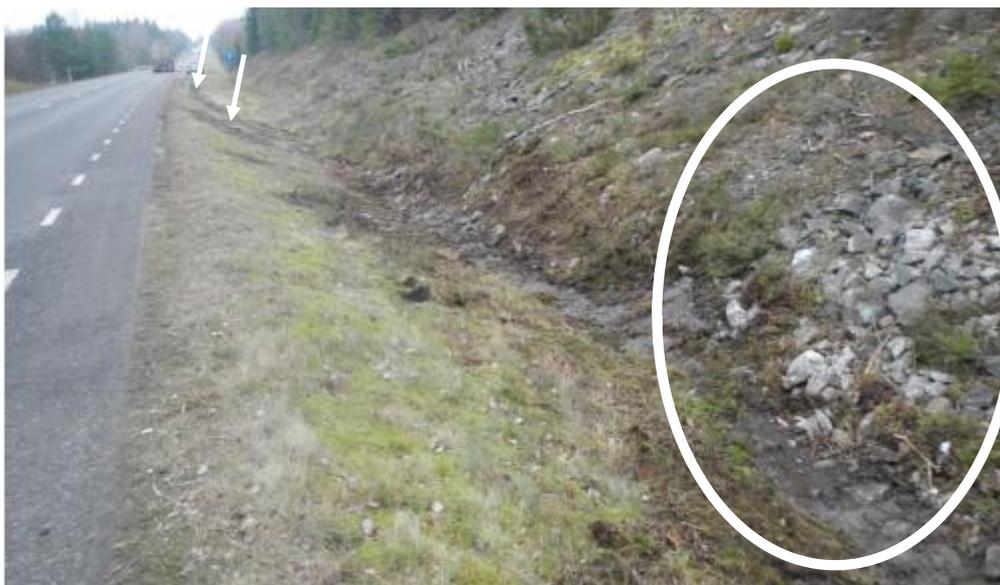
Figure 1. The stones and dirt at a site where a coach with 58 occupants went off the road at 100 km/h because the driver was incapacitated (photo: *SHK, 2015*)

Roadside hazards such as concrete pillars and lampposts are well-known risk factors for vehicles that leave the road as, for example, noted by *Rechnitzer and Grzebieta (1999)*. Many road design rules have been established with the aim of reducing the consequences of a crash. However, a coach crash at 100 km/h has revealed the danger of material currently used on roadsides in Sweden (Figure 1).

To shed light on the possible consequences of crashing on a modern common Swedish roadside where there are stones 2-5 kg sized up to 10–20 cm.

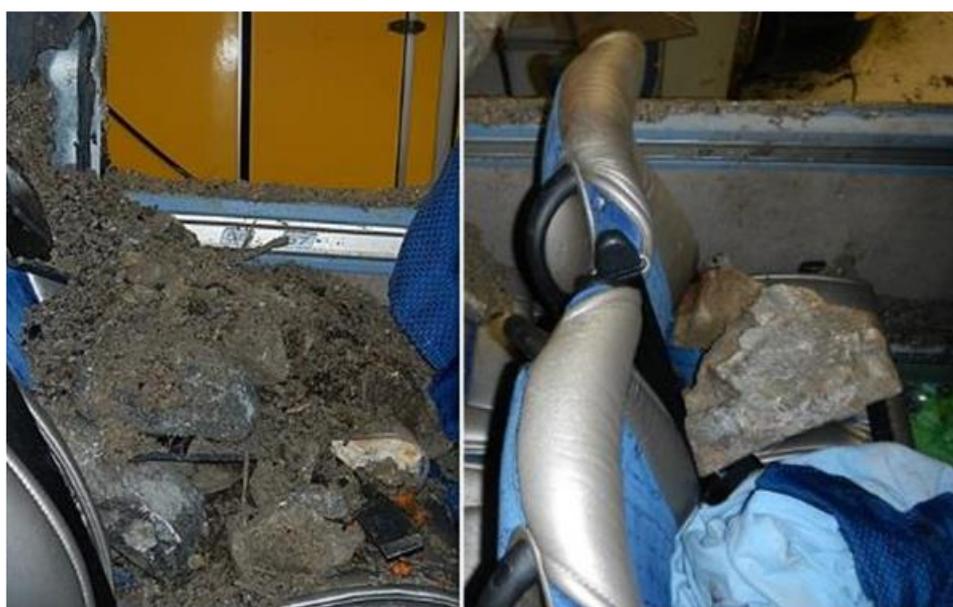
When the left side of the coach hit the ground, all the windows on that side broke and stones and dirt were thrown into the coach (Figure 2). Of the 15 passengers sitting in the window row on this side of the coach, 10 sustained serious or more severe injuries (MAIS 3+) ([AAAM, 2008](#)), many due to the stones and dirt that came flying into the coach. Four passengers had body parts (head, arm) partly ejected through the crushed window. They were injured by impact with the ground, and/or got their arms crushed between the side of the coach and the ground. Of these 15 injured passengers, 12 had used seat belts. One passenger in one of the ‘safest seat positions’ (according to several coach crash investigations) in the row nearest the aisle in the rear, sustained fatal head and neck injuries caused by a 5 kg/10×20 cm stone (right-hand picture in Figure 2).

Figure 2. Interior of the left side of the coach, showing stones and dirt sprayed into it and onto passengers during the crash at 100 km/h (photo: [SHK, 2015](#))

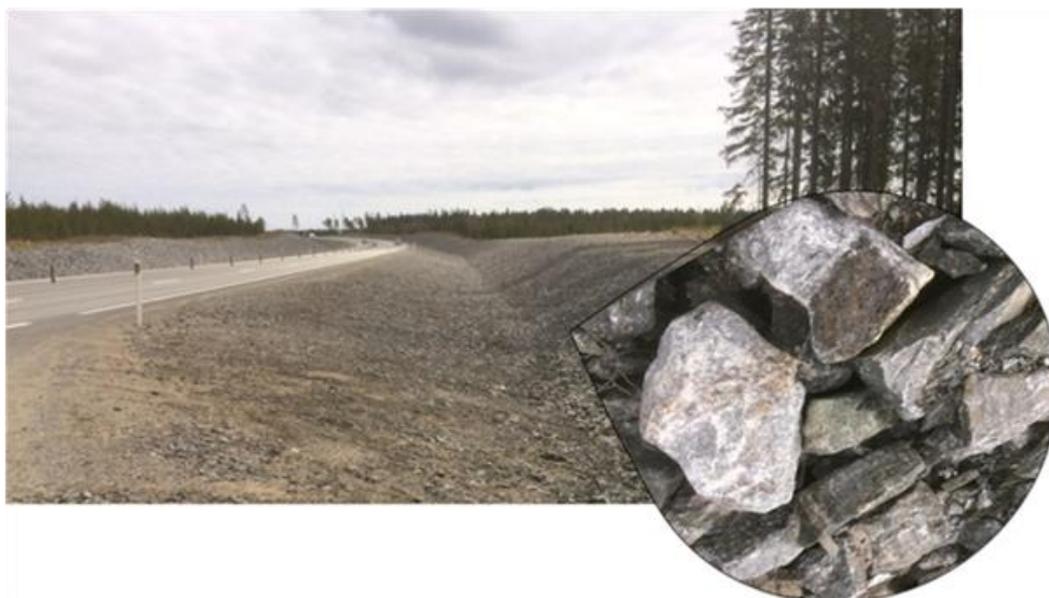
Figure 3. Recently built bypass around a Swedish city, belonging to the ‘Trans European Network’ of roads which in Sweden must be processed through a ‘Road Safety Audit’ during the building process. Clearly, the risk presented in this paper has not been taken into account (photo: *Ulf Björnstig*)

The risk of using this type of roadside material has not been discussed much. This case report may be an eye-opener in that regard, as any vehicle leaving the road—particularly at a high speed—would expose the occupants to this serious risk of injury if overturned. Gravel or sand traps are effective, on racing tracks, at safely reducing the speed of a crash; however, the roadside material used here seems to be very dangerous. This injury risk needs to be accounted for when new roads are built (Figure 3) or when the safety of current road systems are evaluated.

Road Safety Audits (*ETSC, 1997*) and evaluation of road safety within, for example, the European Road Assessment Programme (*EuroRAP, 1999*), may also consider taking this risk into account.
